Re: **FINAL RECLAMATION AND CLOSURE REPORT for the
Drum Mine, Millard County, Utah**

FINAL REPORT
DETAILING THE
RECLAMATION AND CLOSURE
OF THE
DRUM MINE
MILLARD COUNTY, UTAH

November 2000

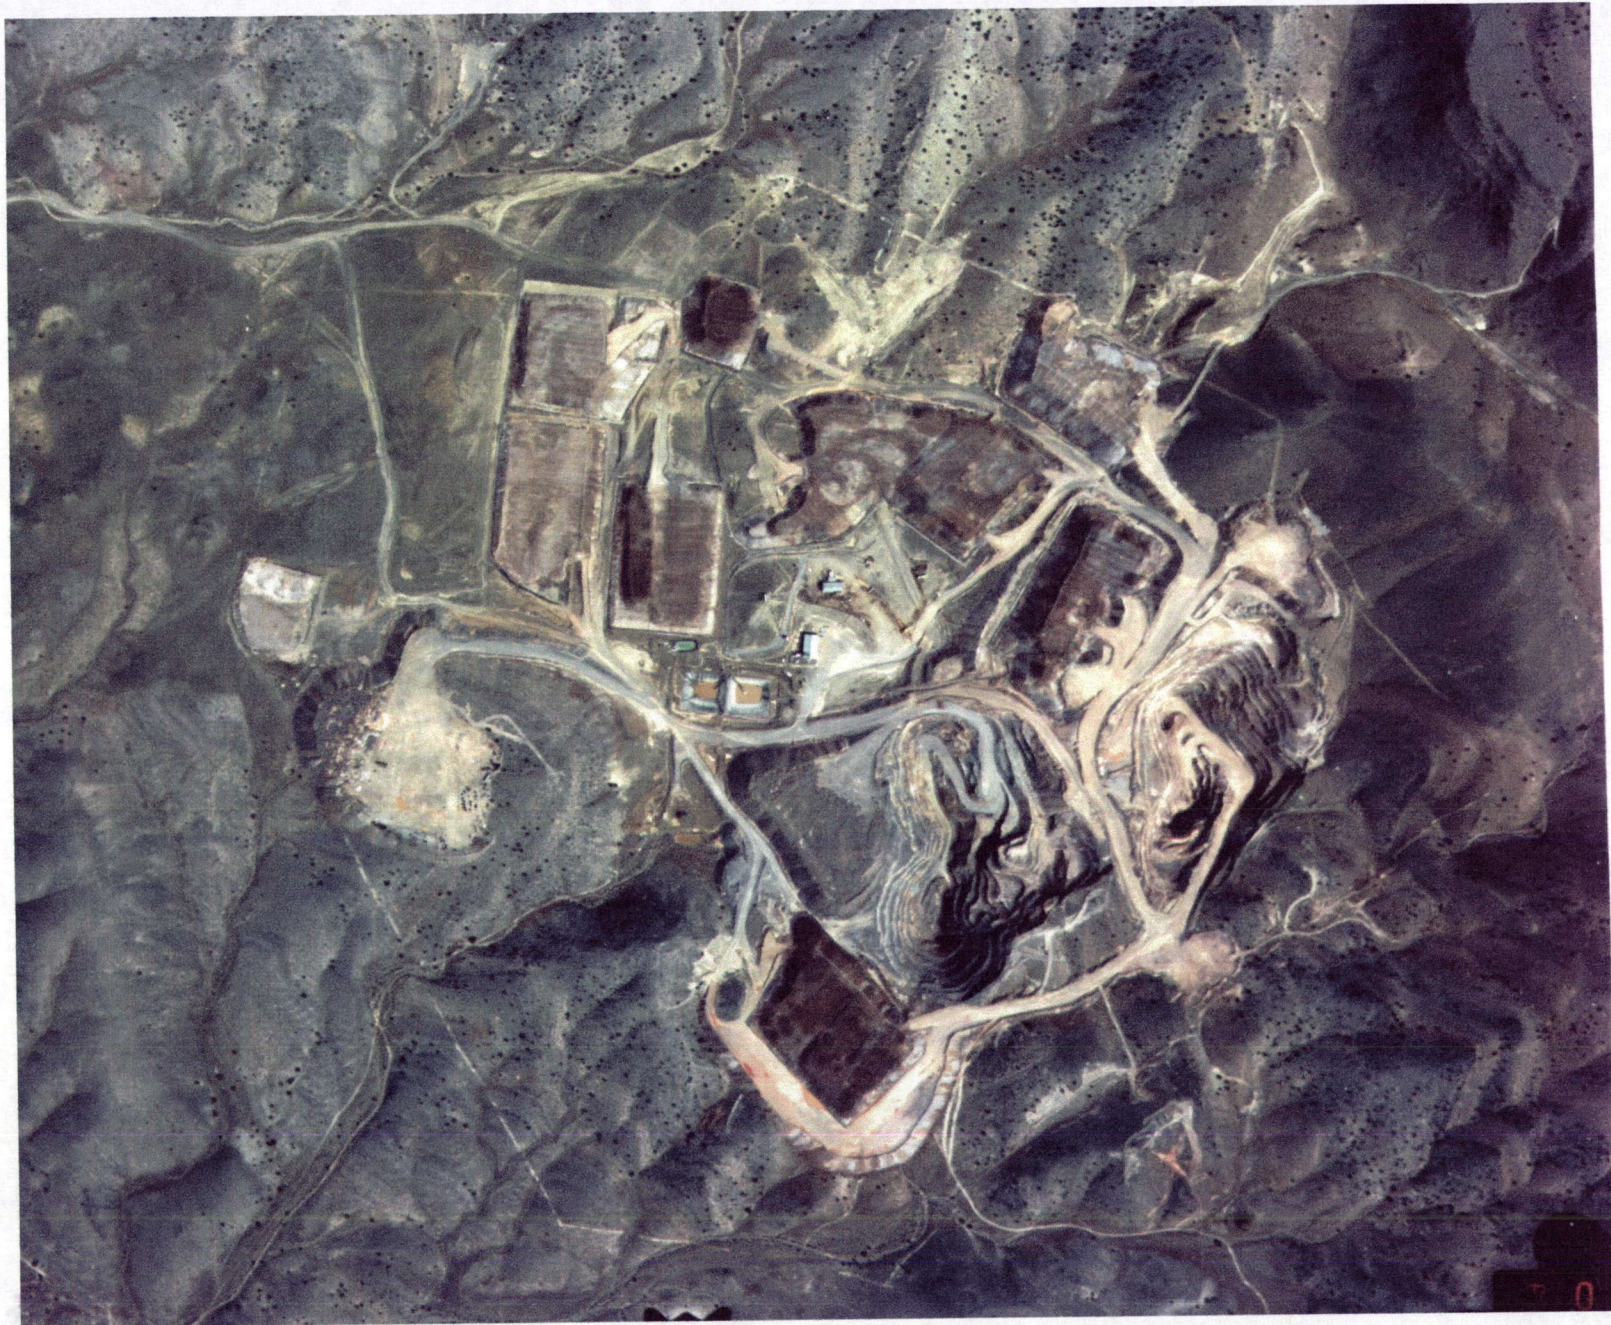
PHOTO #1 – DRUM MINE AS OF JULY 1987

The Drum Mine was a conventional open pit and heap leach facility, which WSMC operated between 1984 and 1987. Jumbo Mining Company (Jumbo) took control of the site after WSMC. Mine waste components generated at the site during mining activity included two low-grade (LG2 and LG3) and six high-grade (HG1 through HG7) heap leach pads. Low-grade heap LG1 was never leached and is thus considered a waste rock dump and high-grade heaps HG4 and HG5 are combined and considered as one heap. Six waste rock dumps (W1 - W4, W7 and LG1), in addition to two open pits and ancillary facilities (e.g., offices, maintenance and process facilities and process ponds) were also left in-place after mining ceased. Photo #1 shows an aerial photo of the site taken in July 1987.

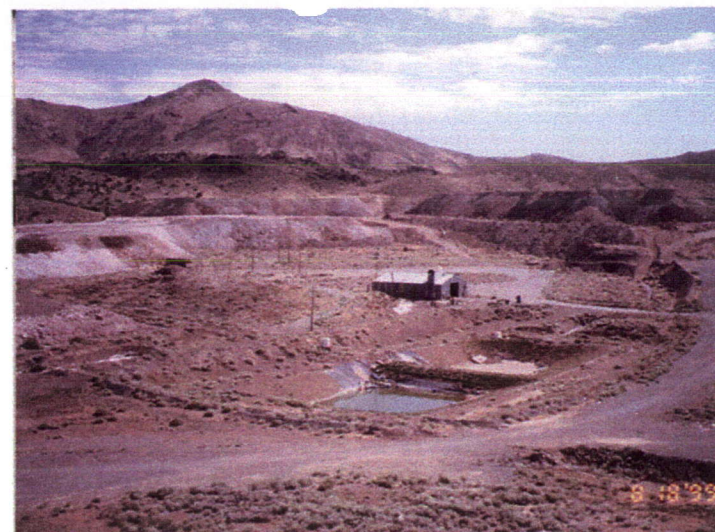
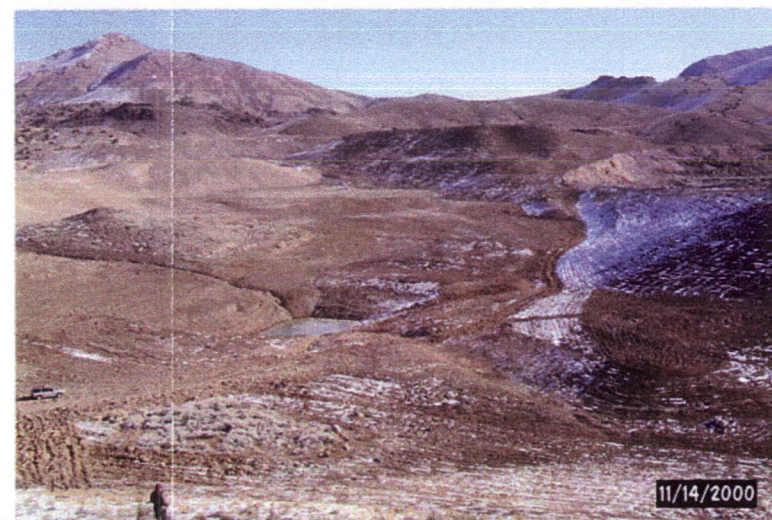
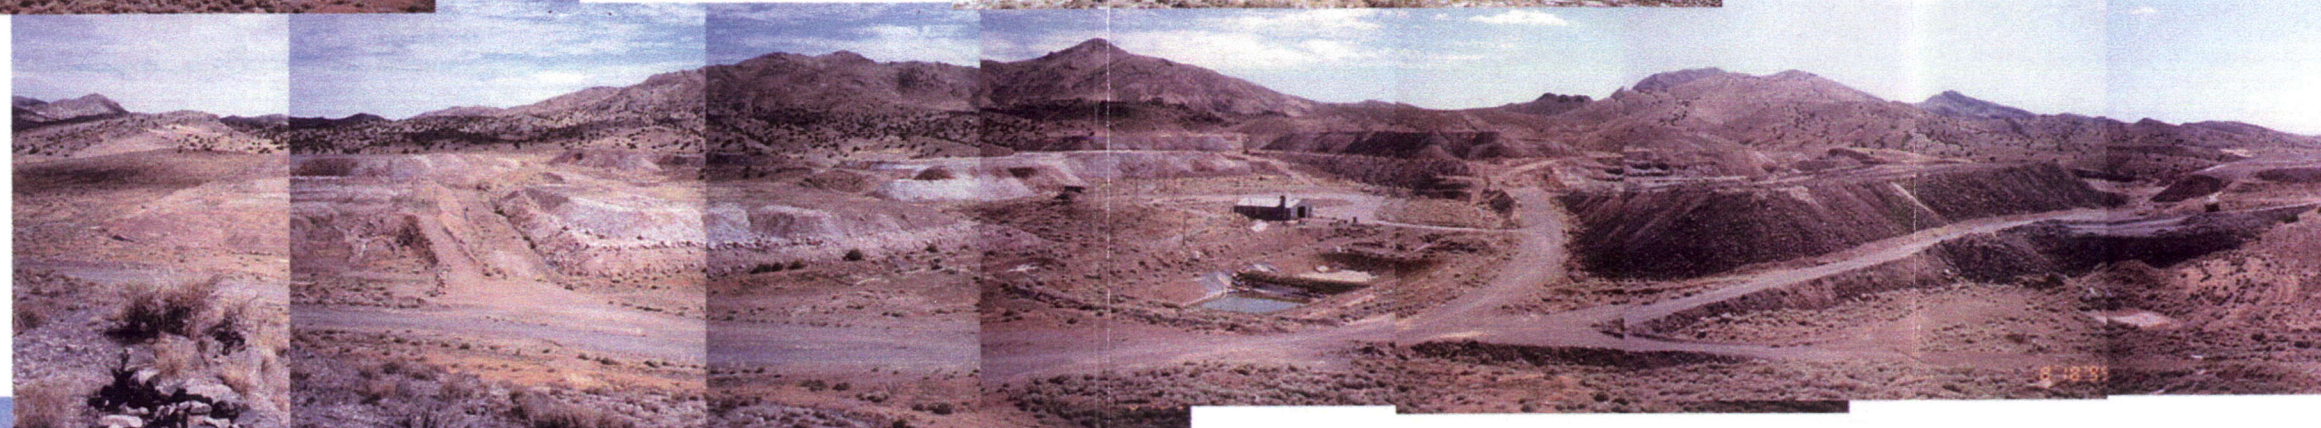
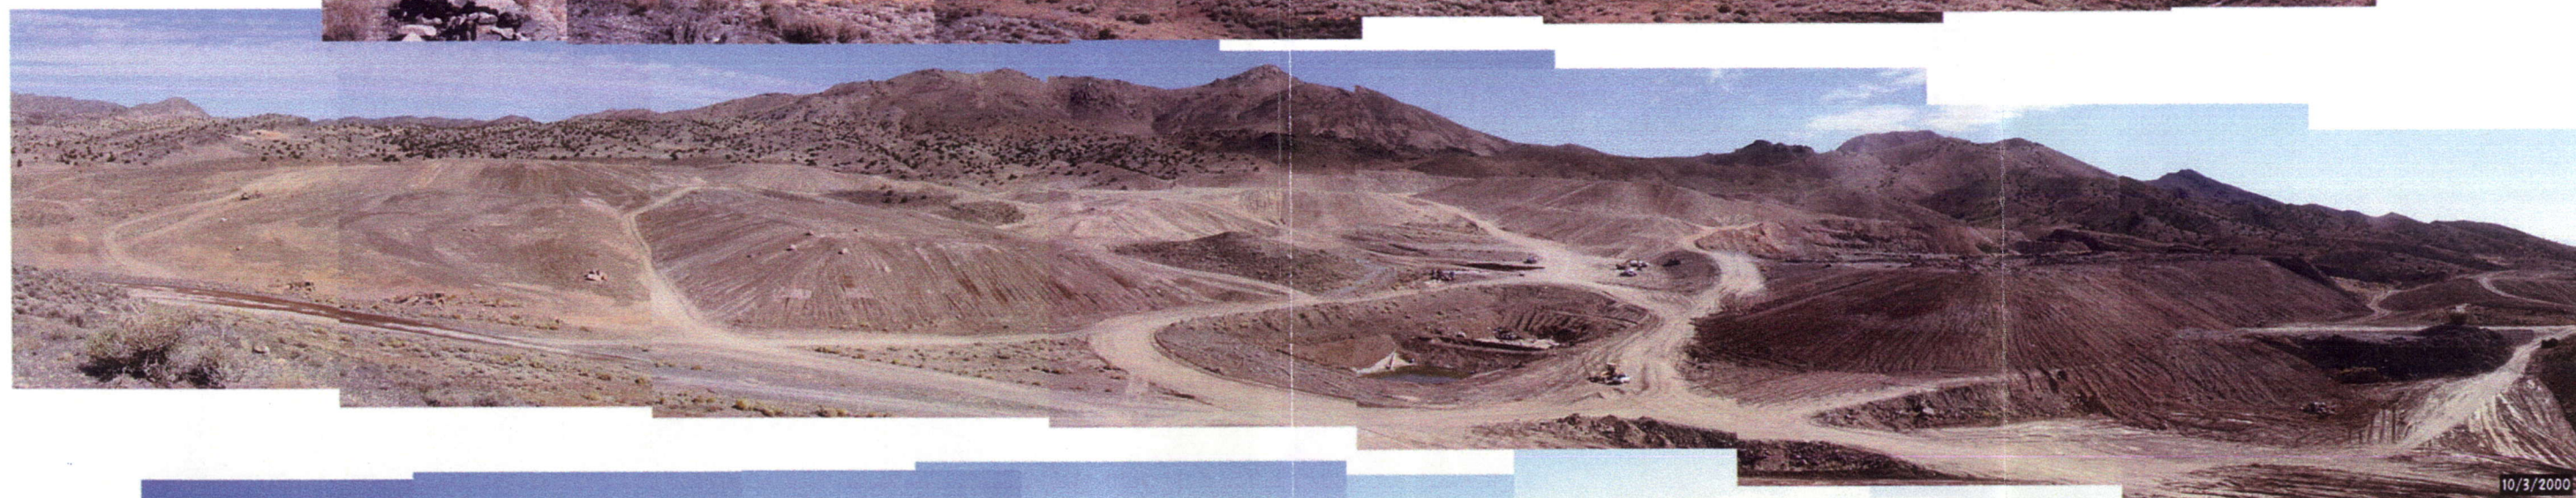
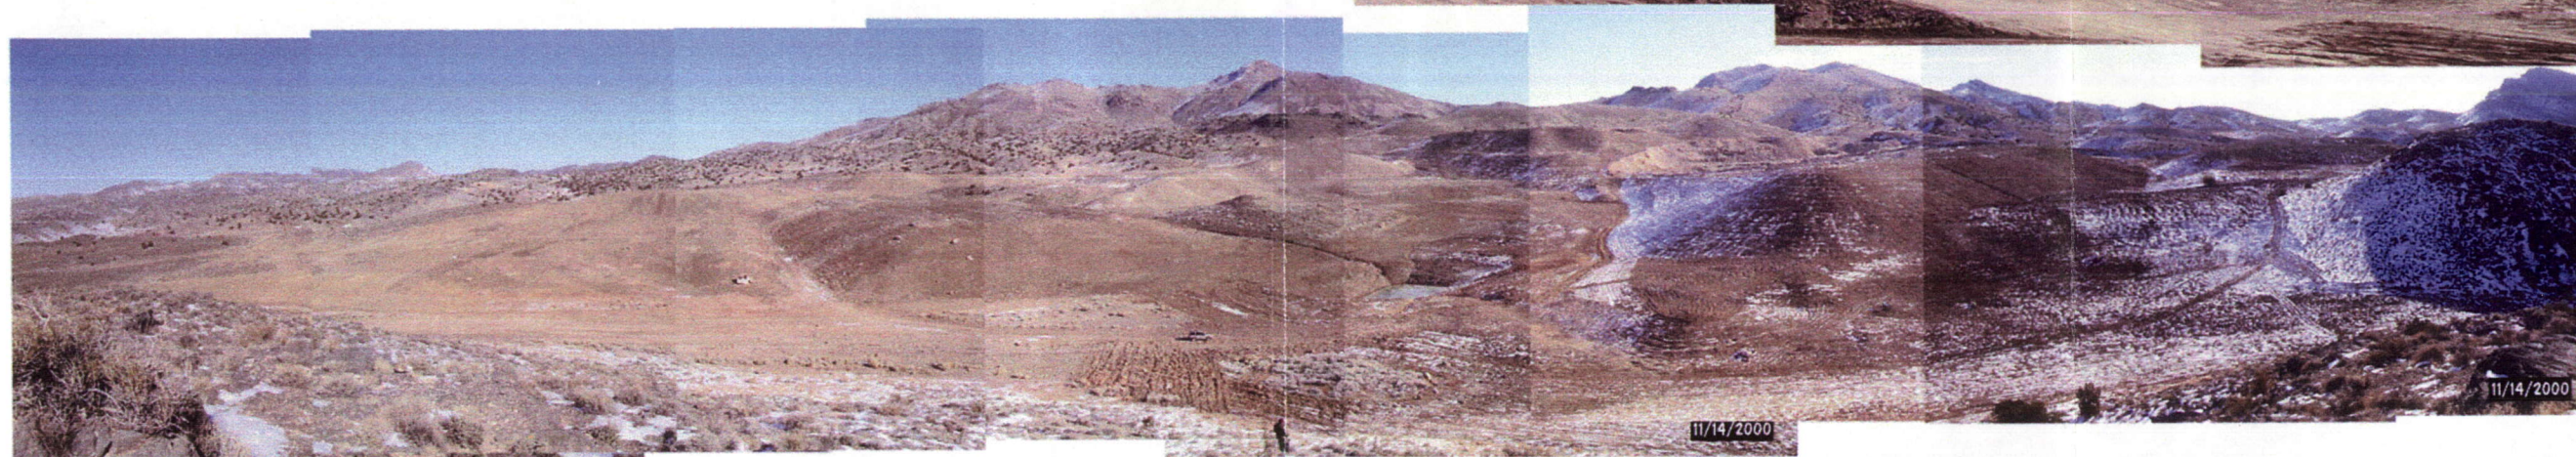
TIME SEQUENCE PANORAMAS

BLM representative visited the site once again on November 28 and approved the work. Photo Page #1 shows several panoramas of the site taken by Doug Jensen. The photos show how much the site has changed from the beginning of reclamation through to the conclusion.

Before Reclamation

After Re-Grading

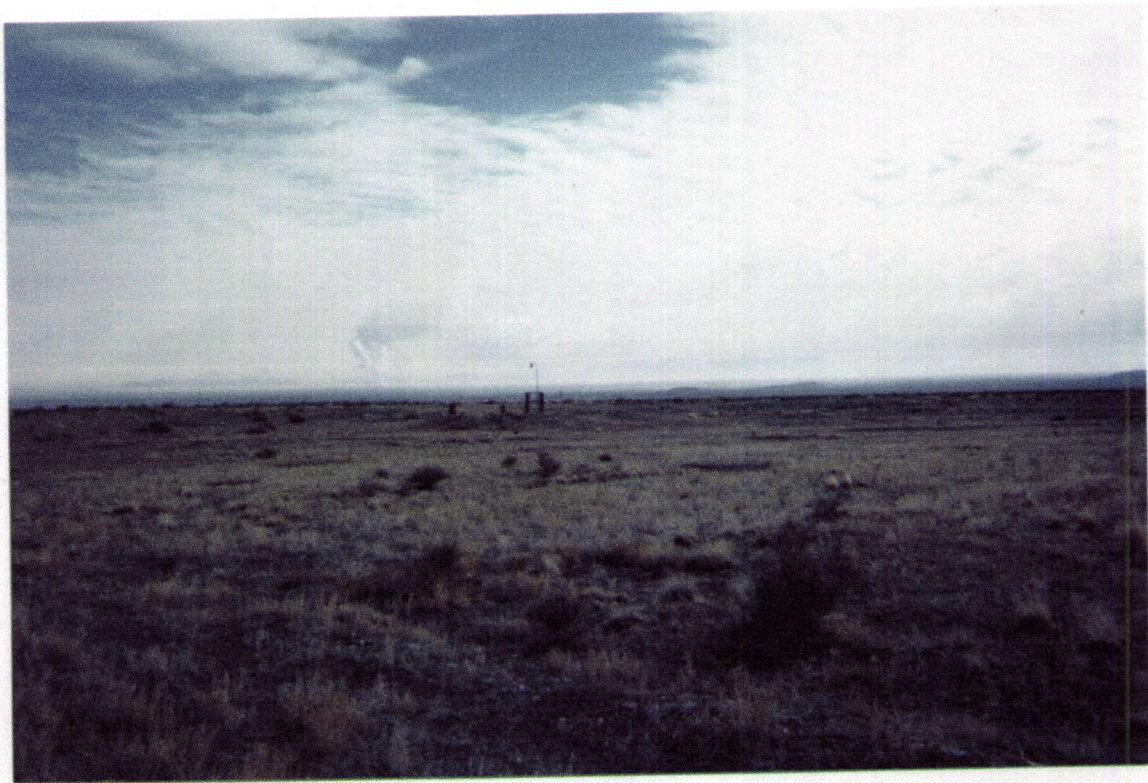
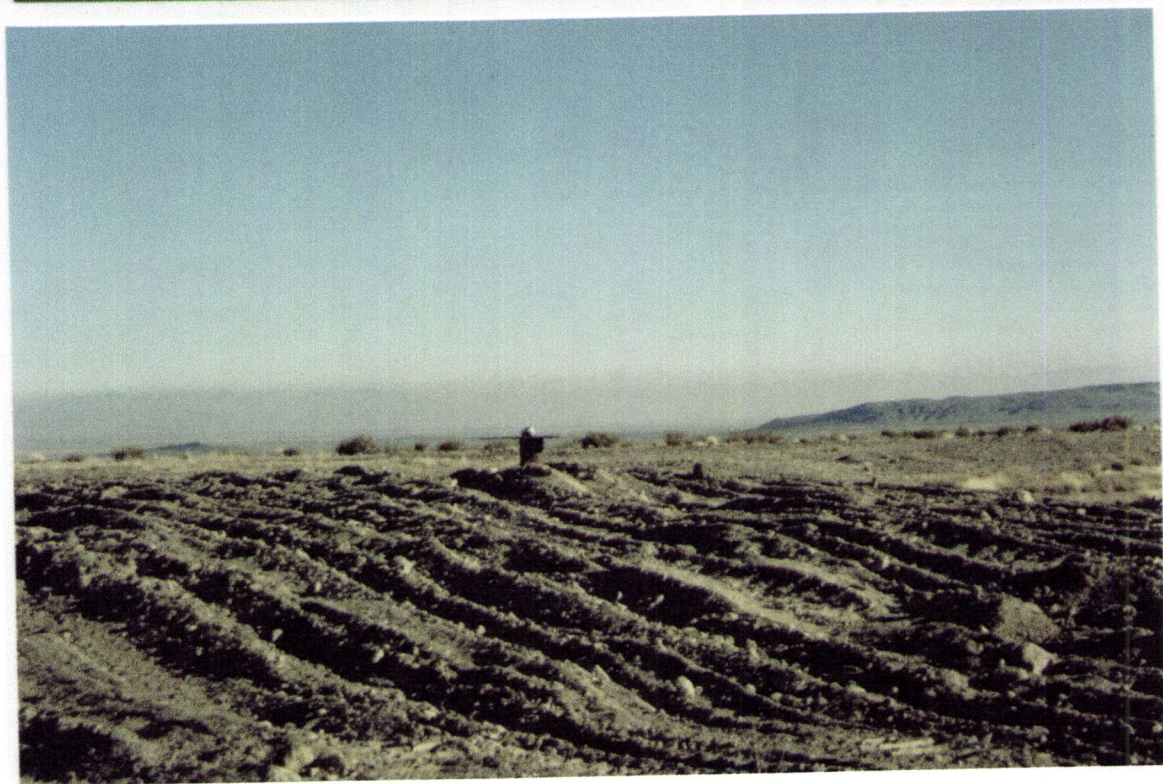
PHOTO PAGE #2
WELLHEAD AREA – WATER SUPPLY LINE

Water was supplied to the mine via an eight (8) mile long pipeline. The wellhead is located near Greener Reservoir southeast of the mine. The water was pumped 2 miles to a transfer pond west of the well where it was then pumped approximately 4 miles to a transfer tank and then onto the mine. The pipeline, tanks and pumps were salvaged. Debris remaining at the wellhead and the transfer tank areas was buried in place. Refuse remaining at the transfer pond area was placed in the pond where the liner was then folded over and buried. All sites were contoured where needed, ripped and hand seeded using the approved seed mix. Before (wellhead and transfer pond) and after (all three sites) photos are shown on Photo Pages #2 through #4.

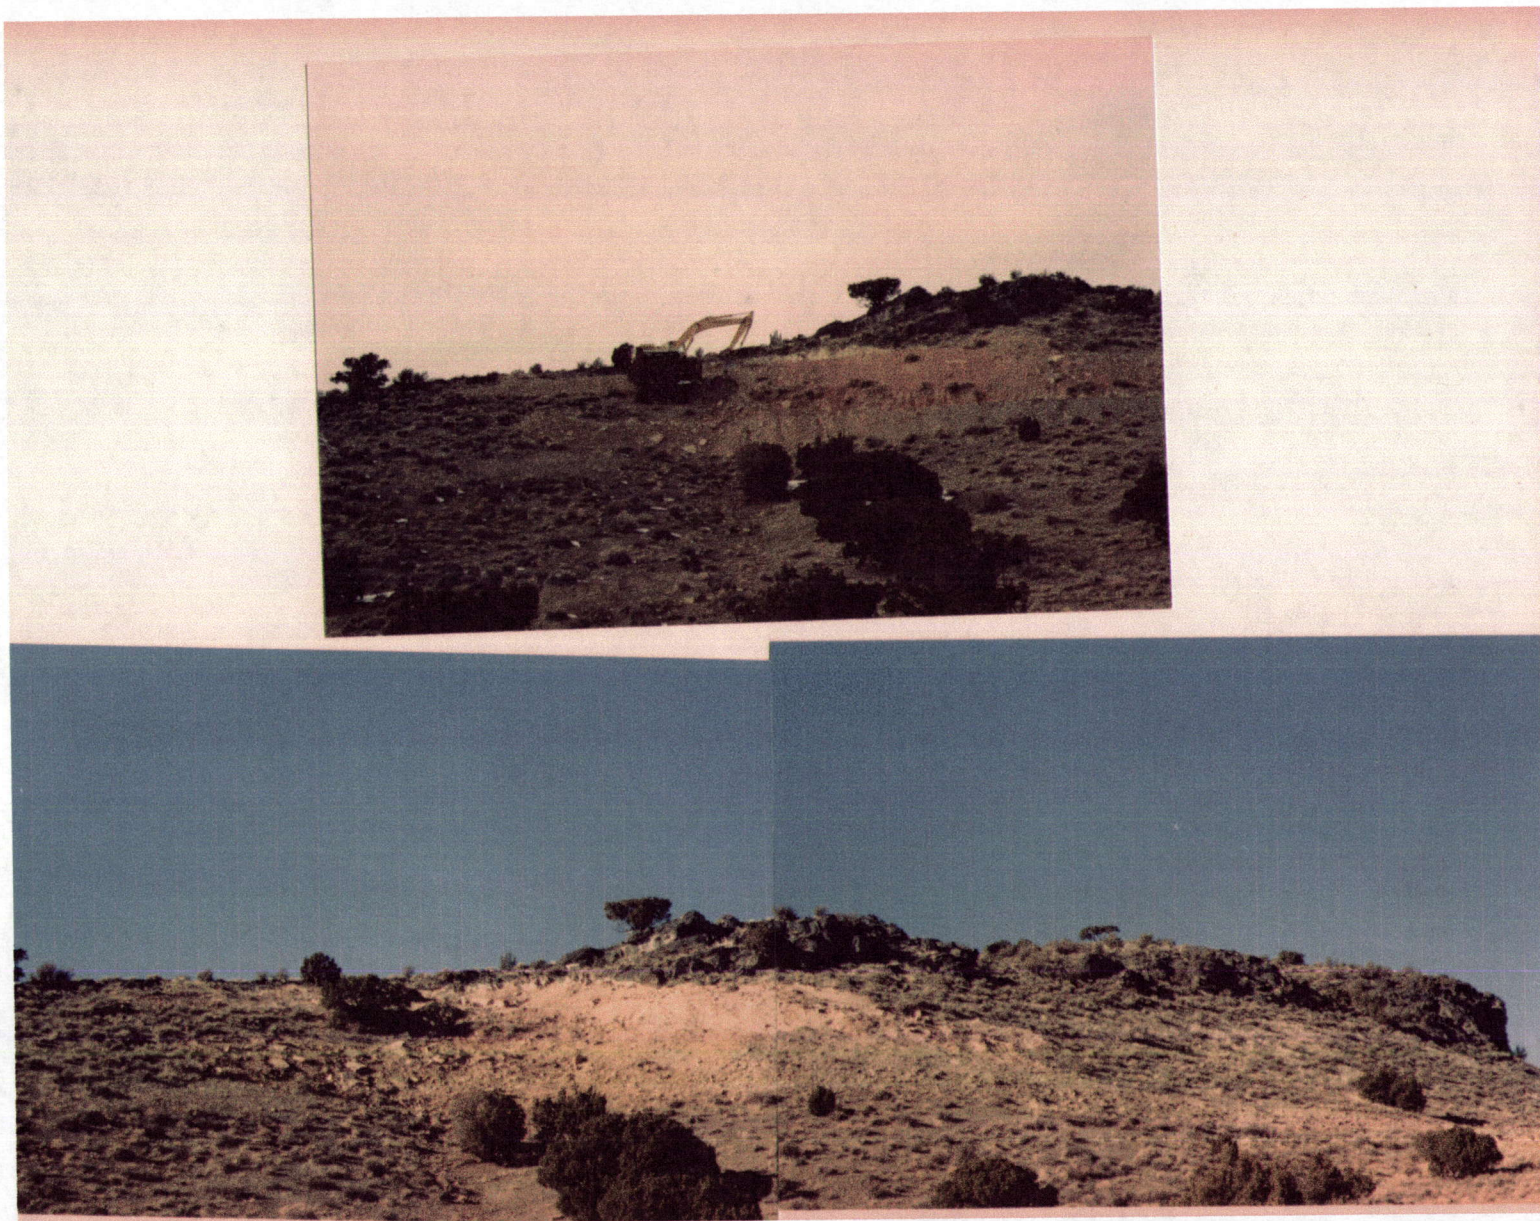
PHOTO PAGE #6
RECLAMATION OF OLD MINE WORKINGS NEAR DRUM MINE

An area approximately ¼ mile northwest from the Drum Mine consisting of old mine workings was reclaimed by WSMC at the request of the BLM. The area, before and after, is shown on Photo Page #6. Reclamation consisted of removing access roads, pulling berm material back off the slope, plugging a decline and re-contouring the area to blend in with the natural slope. The area was hand seeded using the same seed mix as for the Drum site. Reclamation of this site is outside the contract for the Drum Mine and was approved by the BLM on November 28, 2000.

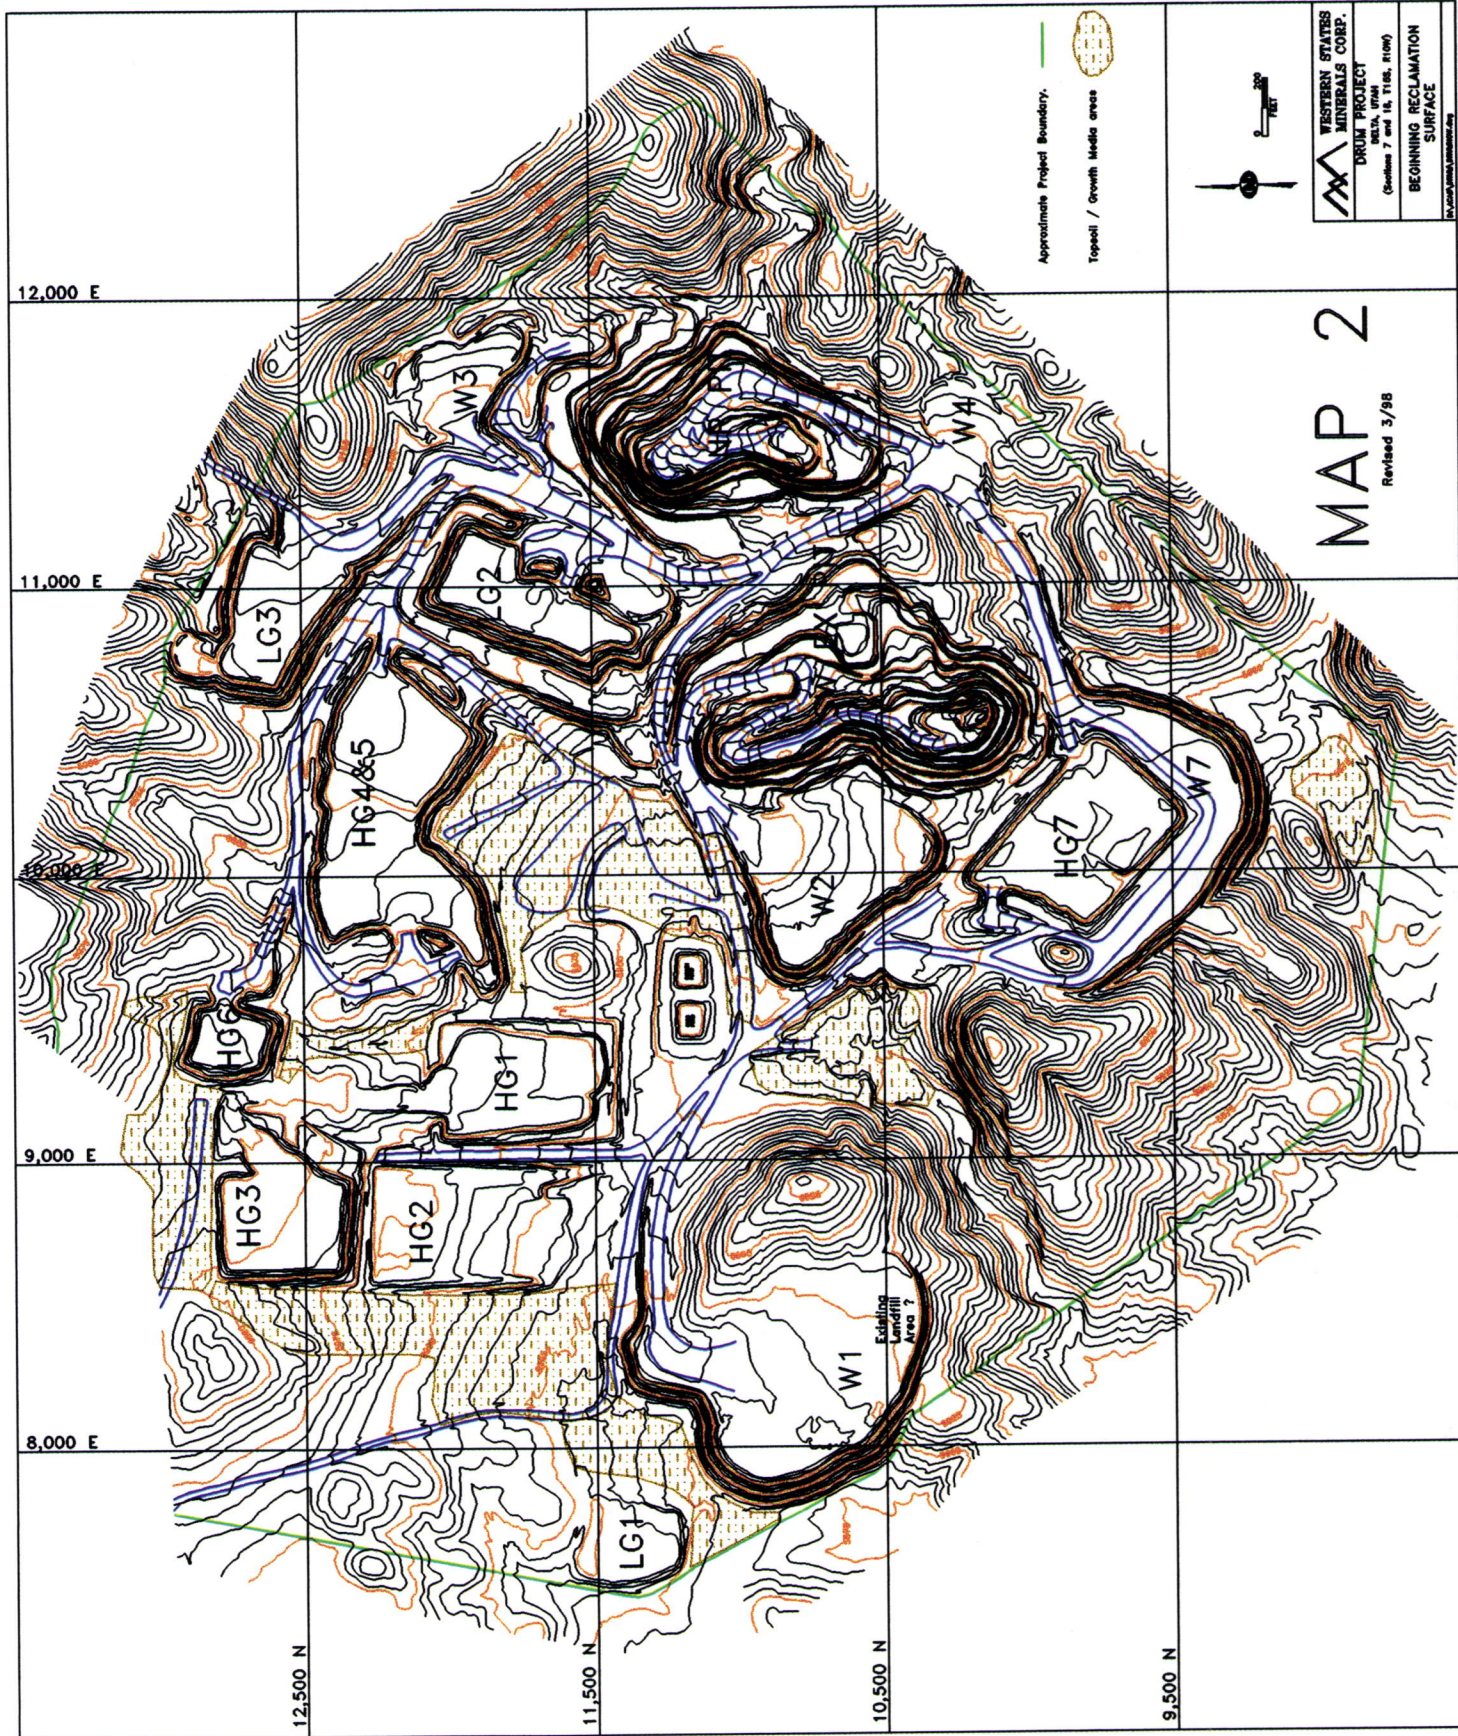
MAP 2

Growth media borrow areas used are shown on Map #2
(Beginning Surface prior to reclamation)

WESTERN STATES
MINERALS CORP.
DEUT PROJECT
MEXICO, U.S.A.
(Sections 7 and 16, T16S, R10W)
BEGINNING RECLAMATION
SURFACE
BY JAMES W. LAMBERT, JR.
